Thermal Diffusion Galvanizing Comparative 1500 Hr B117 Salt Spray Results

# Kortick Manufacturing Hayward, California

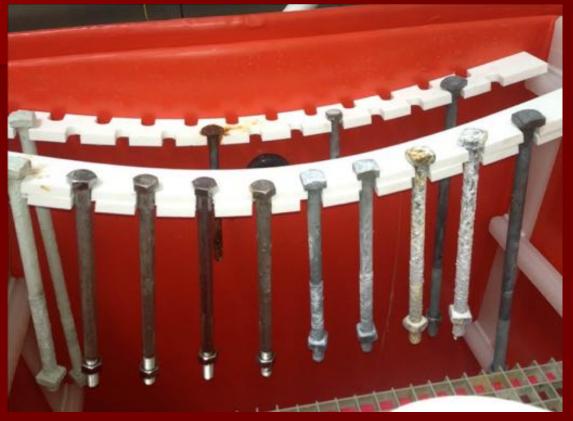
#### **Bolts Tested-Pictured at 500 Hrs**

First row from left to right: ERX painted HDG, 316ss, 316ss, 304ss, 304ss, HDG silicate coated, HDG silicate coated, HDG, HDG, TDG

**Second row from left to right:** ERX painted TDG, Electroplated, Aluminum, TDG

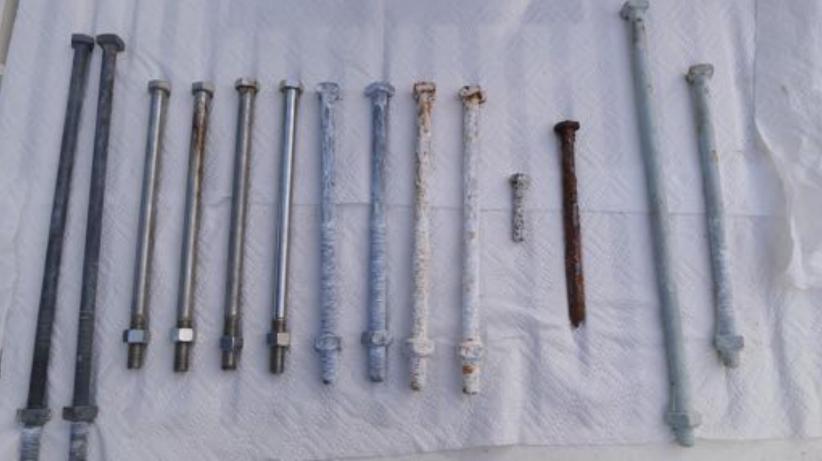
### All @ 1500 Hrs

From left to right: TDG (2), 316 SS (2), 304 SS (2), Silicate Coated HDG (2), HDG (2), Aluminum( 1), electroplated (1), ERX TDG (1), ERX HDG (1)

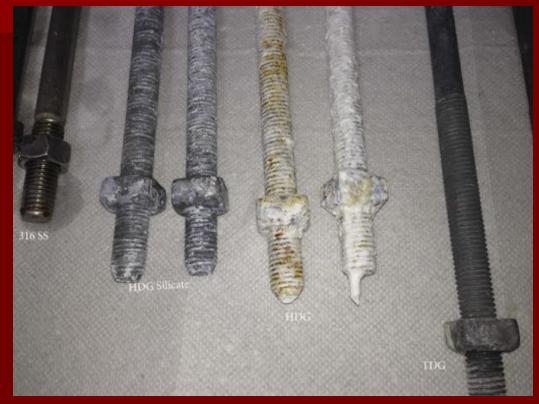
#### Threads close up @ 1000 Hrs

#### Thread Status:

316 SS-one minor corrosionpoint. UsableHDG Silicate-corroded.UnusableHDG-Badly corroded. UnusableTDG-No corrosion. Usable

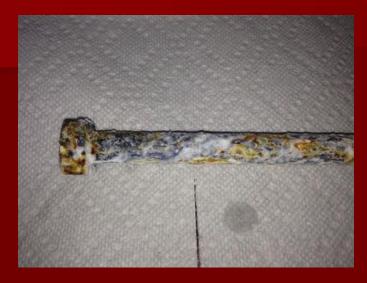
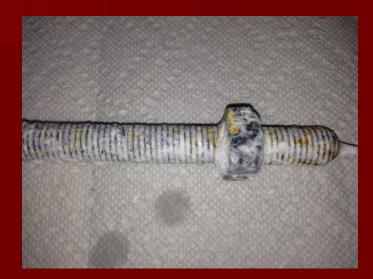
### HDG @ 500 Hrs

<u>Status:</u> Heavily corroded Frozen Threads Unusable

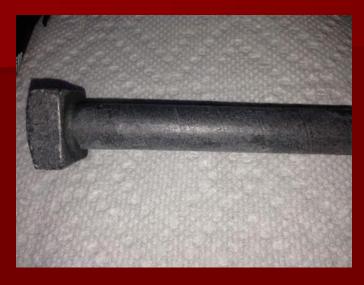
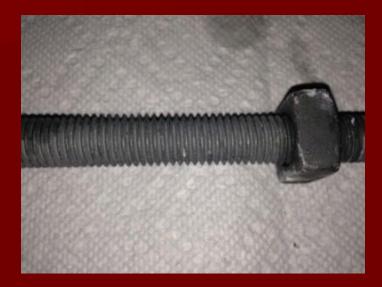
#### TDG @ 500 Hrs

<u>Status:</u> Zero corrosion head, body, chamfer. Free threads with zero corrosion.

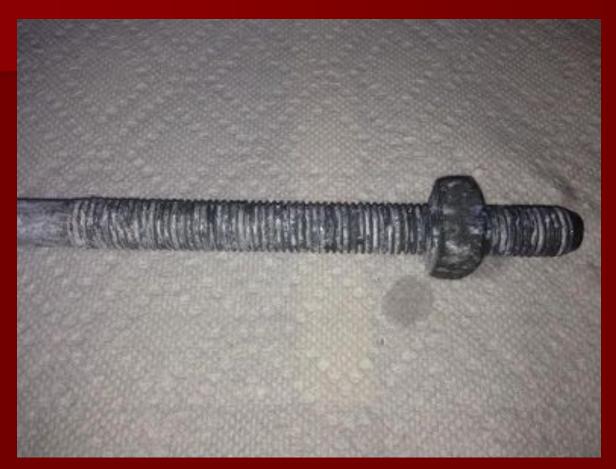
### Silicate Coated HDG @ 500 Hrs

#### Status:

Heavy corrosion head, chamber, body, threads. Frozen Threads, unusable.

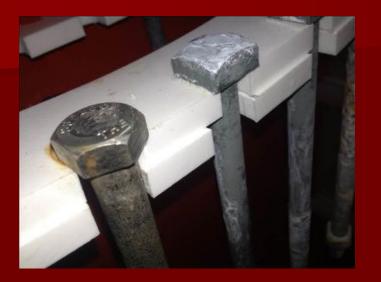
#### 304 and 316 SS @ 500 Hrs

<u>304 Status:</u> Minor corrosion point on head and chamfer. No body corrosion

Fully functional threads, one minor corrosion point.

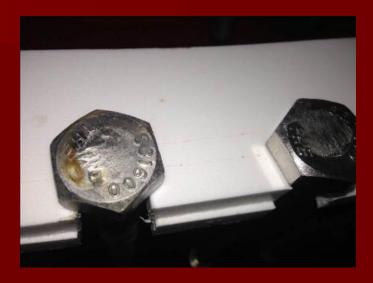
**<u>316 Status:</u>** Minor corrosion point on head and chamfer. No body corrosion Fully functional threads, no corrosion

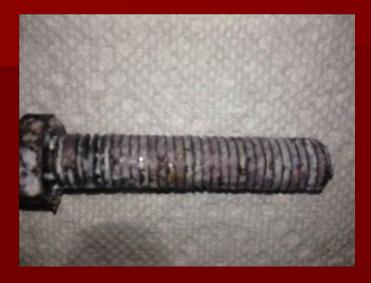
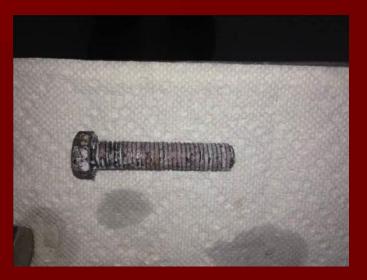
### Aluminum @ 500 Hrs

<u>Status:</u> Heavily corroded unusable

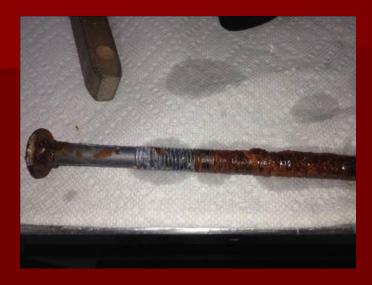
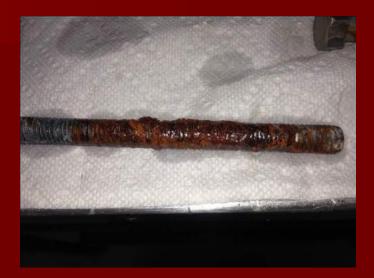
### Electroplated Zinc @ 500 Hrs

<u>Status:</u> Heavily corroded unusable
